## CASE STUDY: Euroseal® Camprofile Thermoseal Camprofile gasket for critical service

Fertilizers  
Ammonia plant

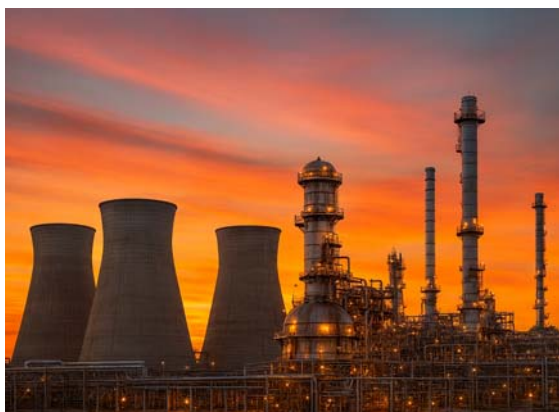
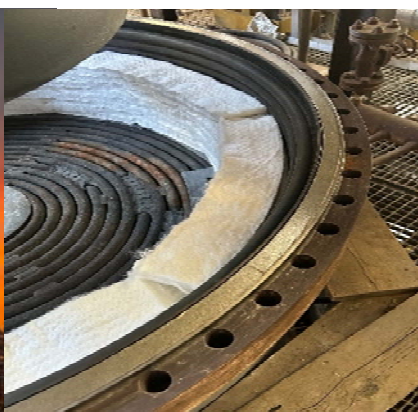
This setup includes an intermediate basket, creating two distinct sealing zones: one upper and one lower, positioned between the flange and the basket. Overall dimensions: 1,700 mm, with a sealing band width of 30 mm. Despite the good flatness of the flanges, sealing anomalies were observed, indicating critical issues likely related to factors beyond surface geometry alone.

The Euroseal Camprofile gasket in AISI 304, equipped with a 1 mm Thermoseal® coating on each side, successfully passed the hydrostatic test, ensuring leak-tightness of the reactor even under operating conditions. Compared to the Spiral Wound Gasket, the greater mechanical strength of the Camprofile significantly simplified storage, handling, and installation operations, confirming the reliability of the solution even in highly demanding environments.
